NON-DESTRUCTIVE ASSESSMENT OF CONCRETE DURABILITY OF THE NATIONAL MUSEUM OF WESTERN ART IN JAPAN

K. Imamoto (1), A. Tanaka (2) and M. Kanematsu (3)

(1) Faculty of Engineering, Tokyo University of Science, Tokyo, Japan

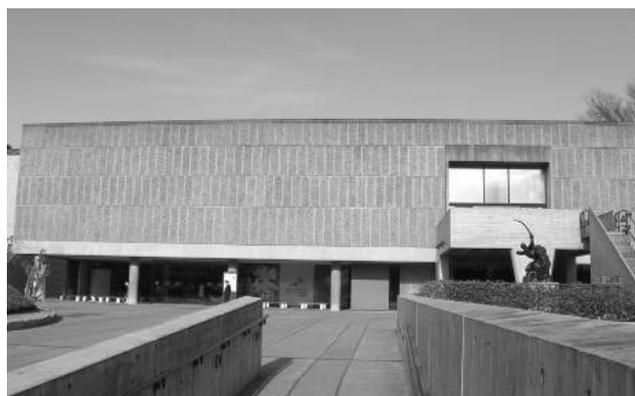
Photograph 1: Appearance of the NMWA

The NMWA (Photograph 1 and Figure 1) was constructed in 1959 with a concrete design strength of 18 MPa. Further details of the building and specifications of the concrete mixture are listed in Table 1 and 2, respectively. Round bars with a yield strength of 235 MPa were used for reinforcement [2].

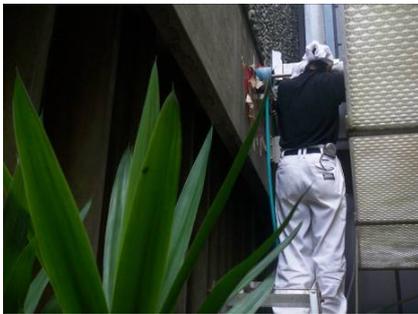
Photograph 2 : Core drilling

Small core specimens with a diameter of 20 mm were drilled in the structure in order to determine the relationship between the air permeability coefficient (kT) and the carbonation progress of concrete. The carbonation progress was measured, as shown in Photographs 2 and 3. After the core drilling, grout for the repair was injected into the hole and the sliced surface of the core was installed back into the structural member (see Figure 3). This process enables the impact of the core drilling to be invisible as shown in photograph 4.

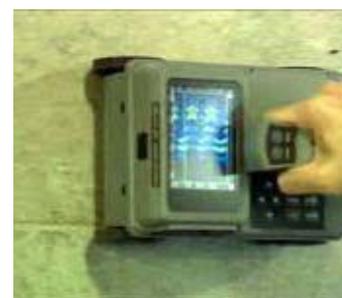
The concrete cover depth and the steel bar arrangement were measured with a radar device shown in Photograph 5. This method utilizes the reflection of the radar from the device onto a steel bar installed in a concrete member. The receiver measures the round trip time, from which the position of the steel bar can be detected based on the relationship between the velocity and time of radar in concrete.

Photograph 5 : Radar device

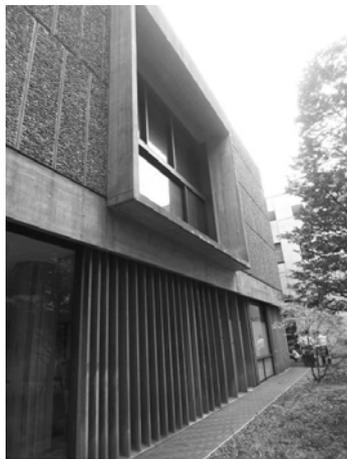
Figure 6: North-side of NMWA

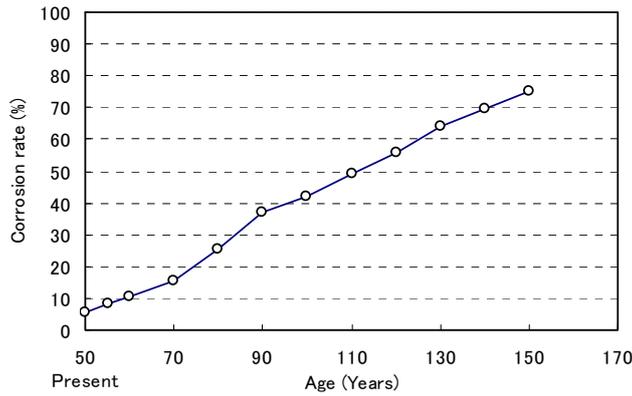
Figure 9: Progress of steel bar corrosion rate in north-side exterior wall
